# Improving the Ecological Function of the Upper Bow River: Bow Lake to Kananaskis Dam

Technical Report #7  
April 2009

By: Matt Blank and Tony Clevenger

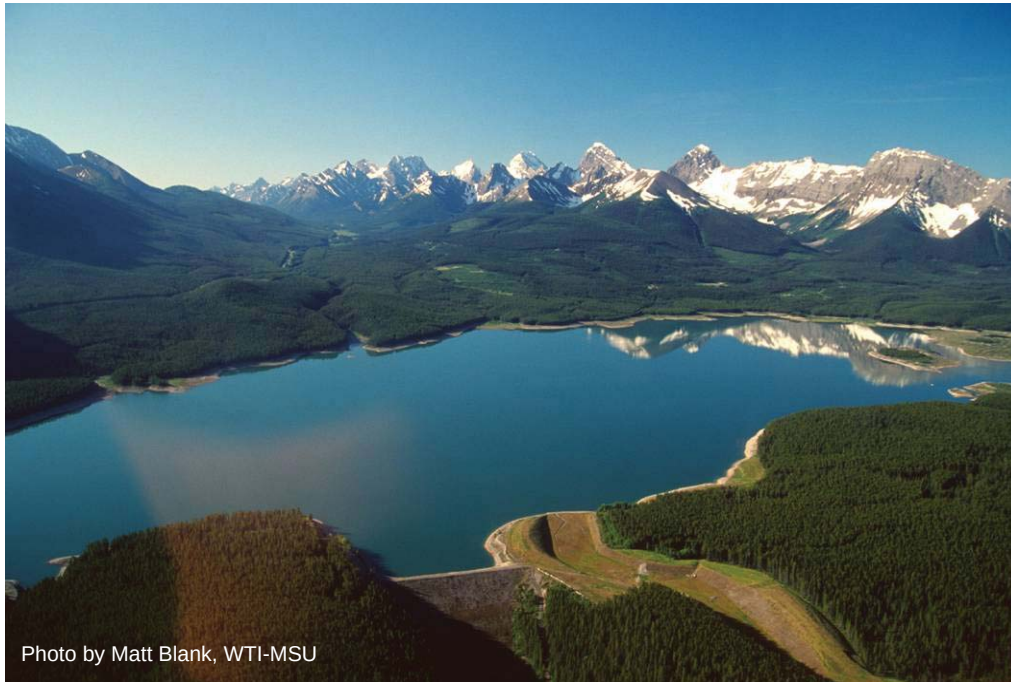
**Figure 9.** Canyon Dam located on the Spray River System.

A major tributary watershed to the Bow River in Reach 3. Prior to construction, the Spray River flowed through the channel outlined in the foreground. Currently, 75% of the water is directed toward Canmore.

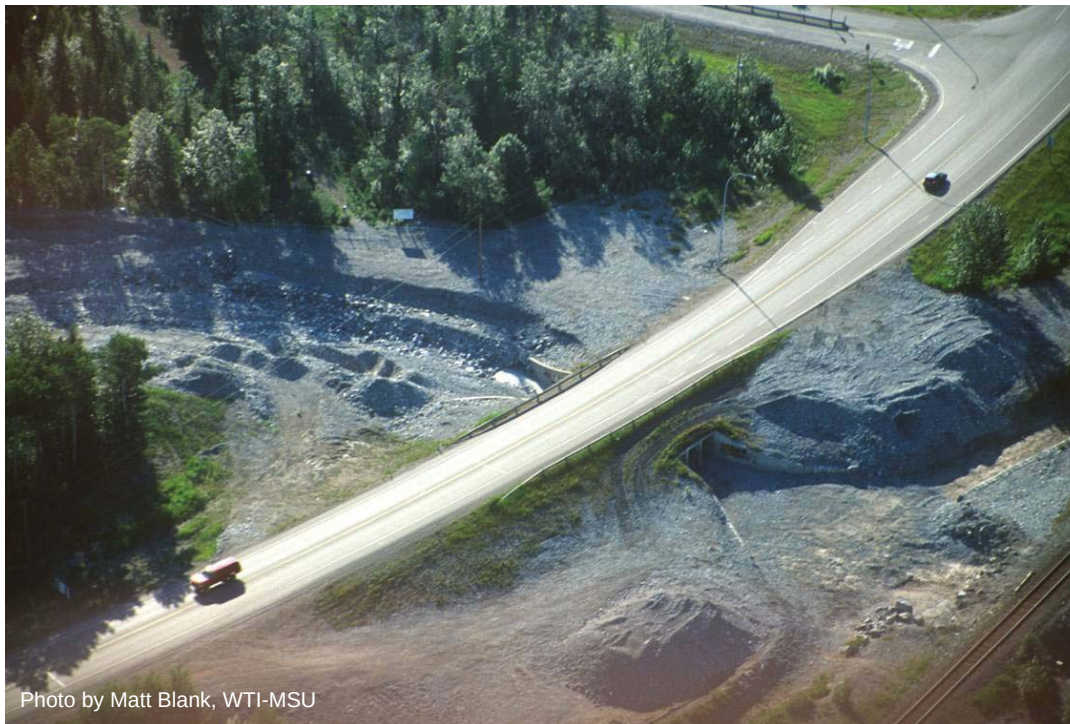
Impacts to the watershed in this Reach from transportation infrastructure include changes to natural geomorphic and hydrologic processes, reduced aquatic connectivity through barrier culverts, and changes to water quality from highway and railway runoff. A specific example that shows the effect of a road on geomorphic and hydrologic processes is Cougar Creek (Figure 10). The road crossing at Cougar Creek is too small and interrupts the natural flow of sediment, debris and water from upstream to downstream across the highway. This disruption starves the downstream aquatic habitat of necessary and important inputs from upstream.

**Figure 10.** An alluvial fan interruption by Highway 1A and CP Railway
